Radiological Recovery Requirements, Structures, and Operations Research

Volume IV,**Decontamination****Analysis of Selected Sites****and Facilities in Detroit, Michigan**

FINAL REPORT: VOLUME IV, Decontamination Analysis of
Selected Sites and Facilities in Detroit, Michigan

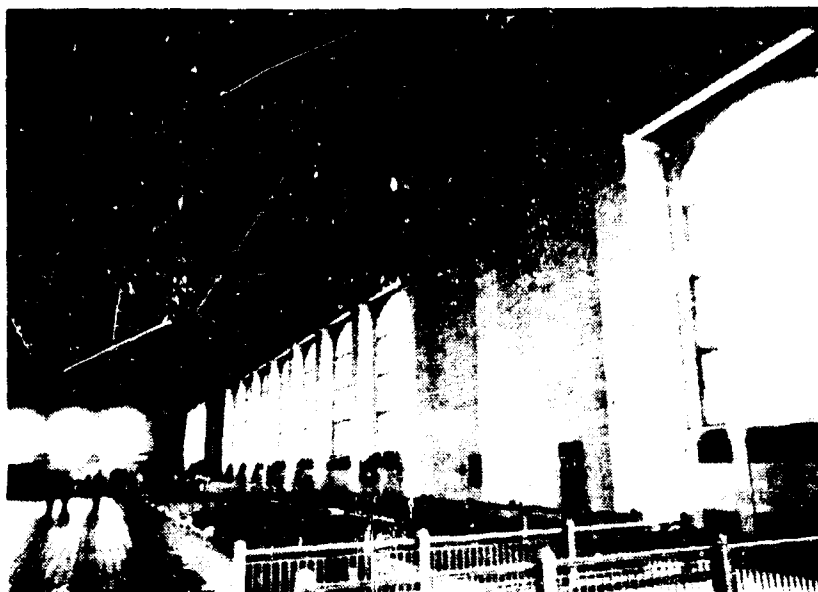
Figure 27

View 1 - Springwells Station -
A View of the Interior of the Pumping
Plant Shcwing the Heavy Wall Construction
and Large Windows

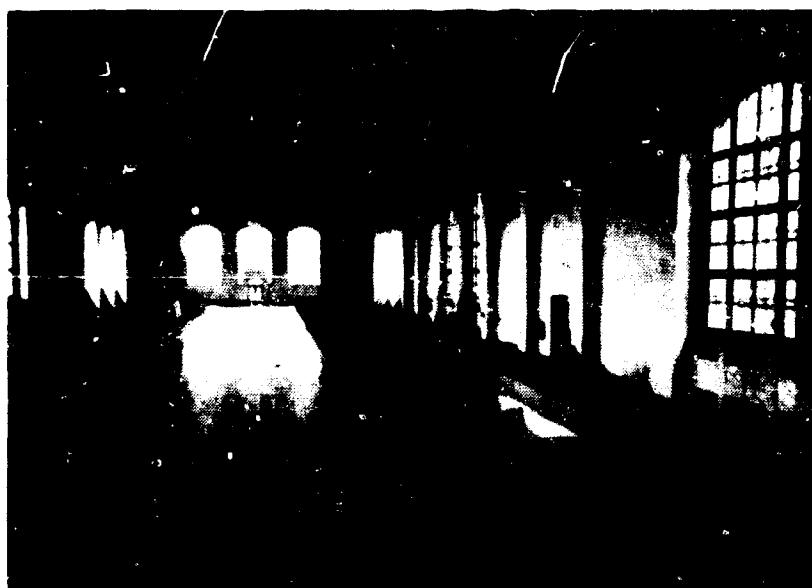
Figure 30

View 4 - Springwells Station -
A View of the Interior of the High Lift
Pump Section of the Pumping Plant

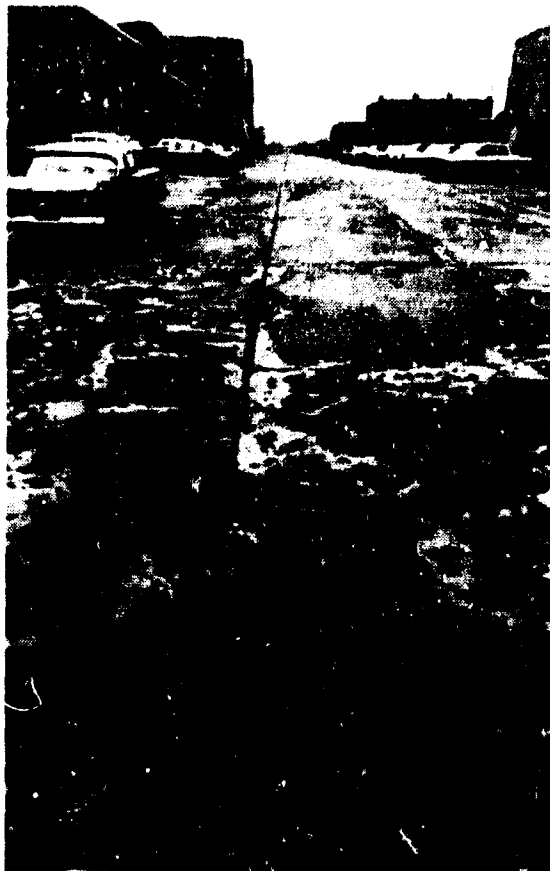
Figure 43

View 17 - Springwells Station -
An Exterior View of One of the Driveways
Between the Buildings Showing a Typical Drain

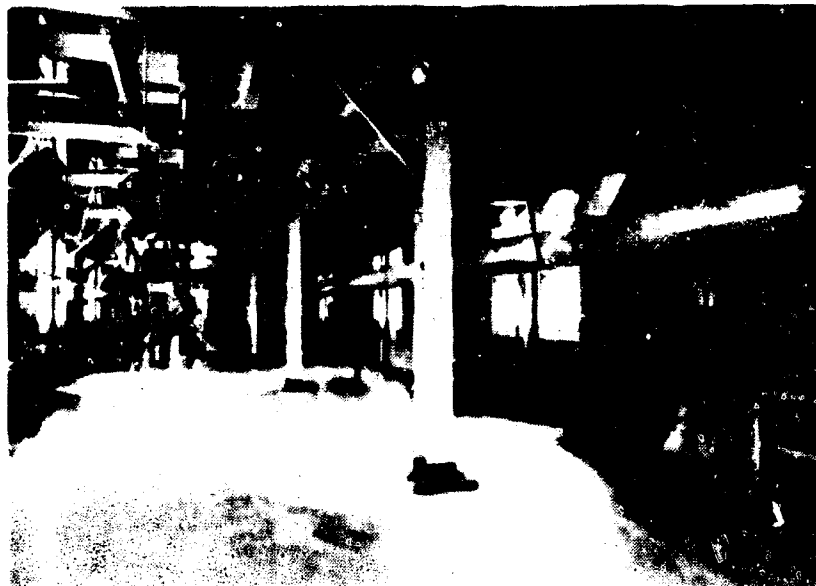
Figure 46

View 20 - Springwells Station -
An Interior View of the Mixing
Chamber Attached to the Old
Filter Building;

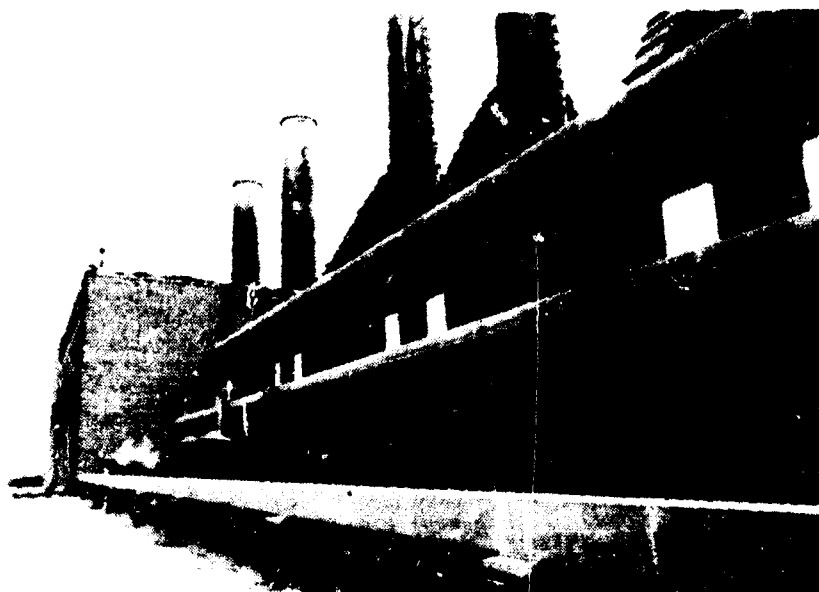
Figure 70

View 15 - Mistersky Power Plant -
A View of the Several Levels of Roofs
on the Plant Building

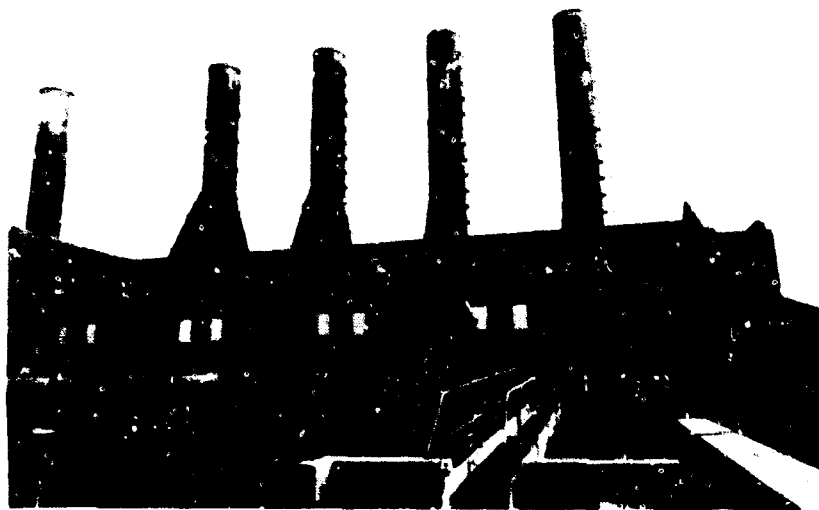
Figure 78

View 23 - Mistersky Power Plant -
A View of the Upper Roofs Over the
Boiler Rooms Showing the Large
Obstructions to Decontamination

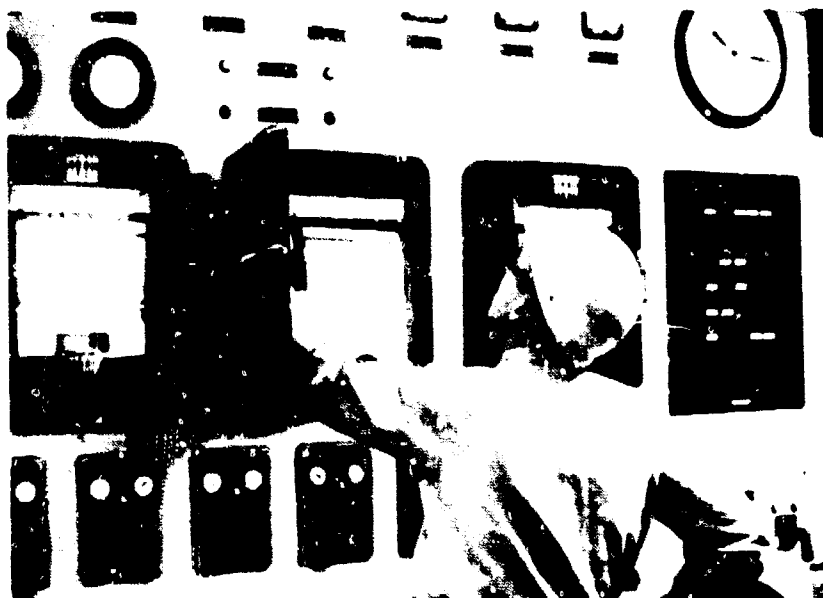
Figure 81

View 26 - Mistersky Power Plant -
A View of the Remote TV Control
to the Screen House

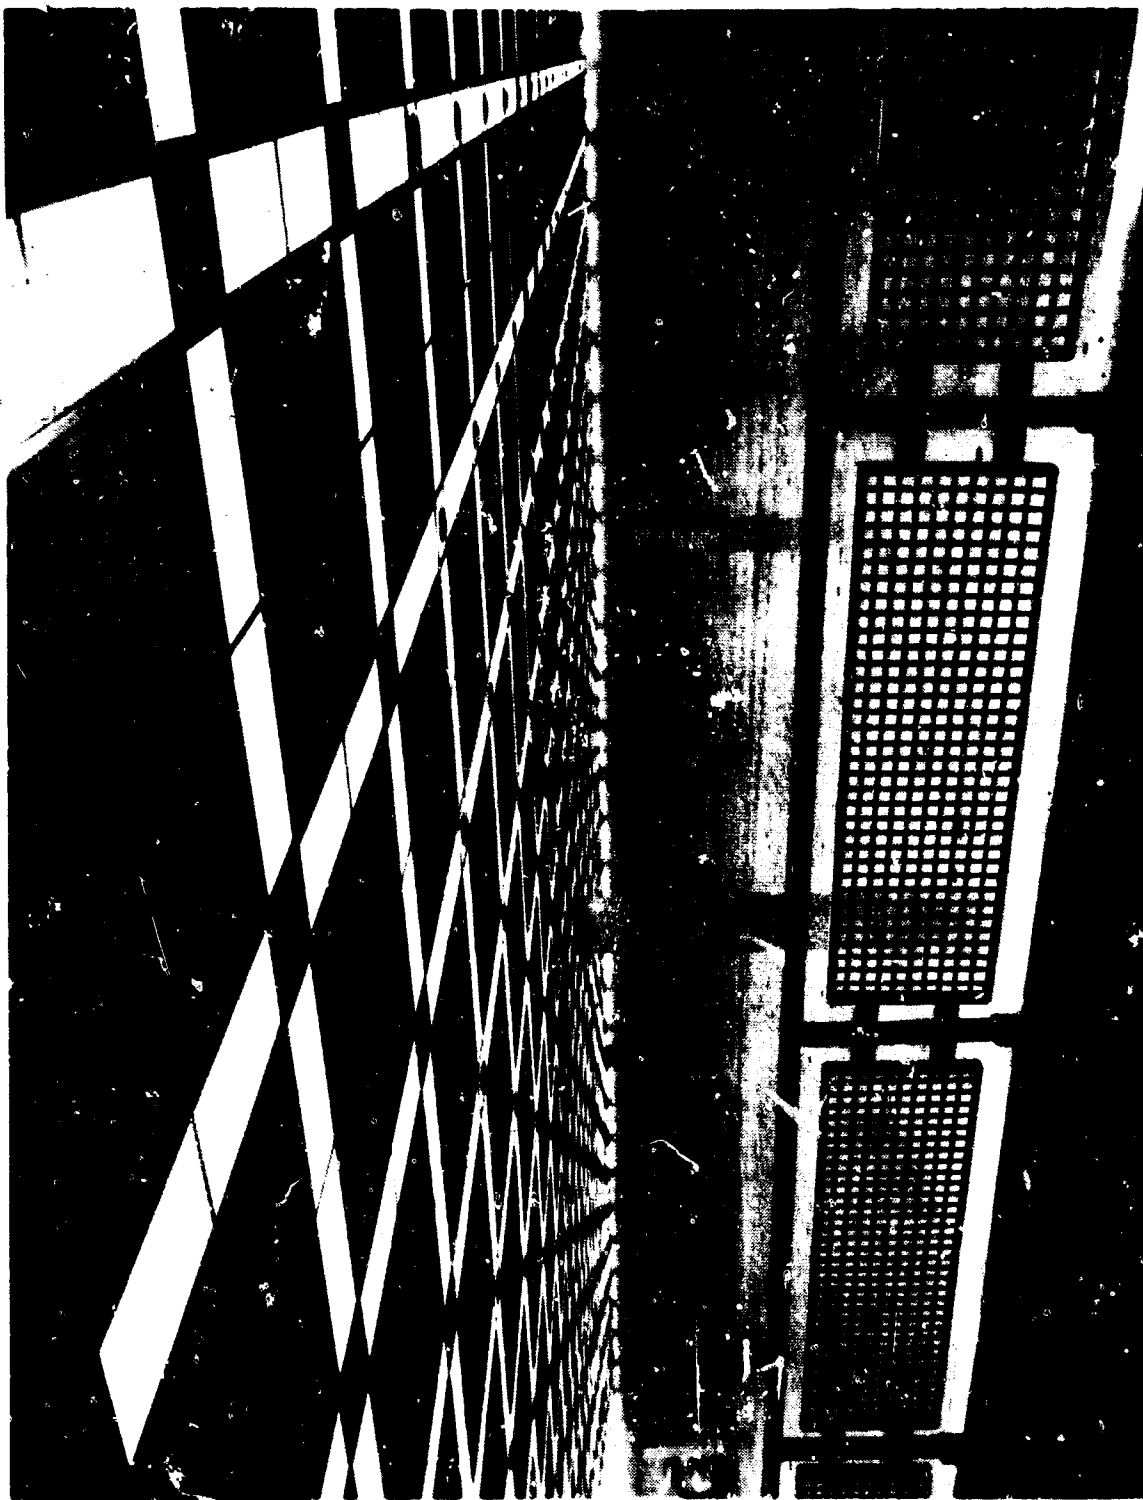
Figure 94

View 2 - Cobo Hall -
A View of the Main Exhibition Hall in the
Exhibition Building

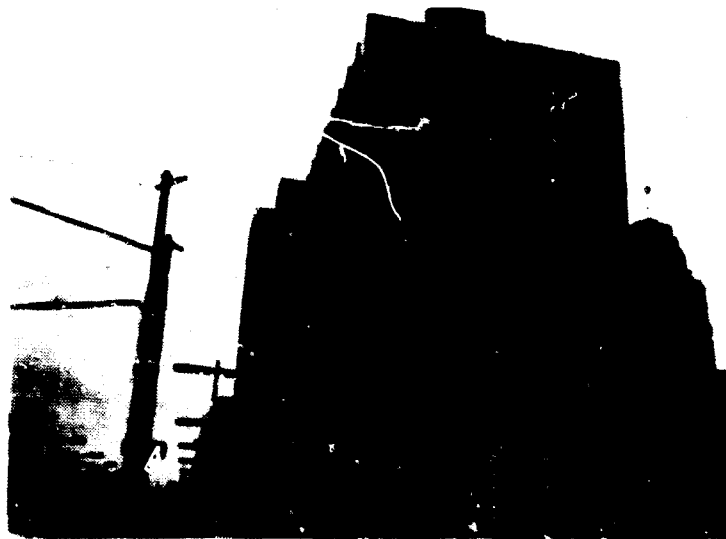
View 3 - The City-County Building -
A View of the Brick (East) Wall of the
City-County Building

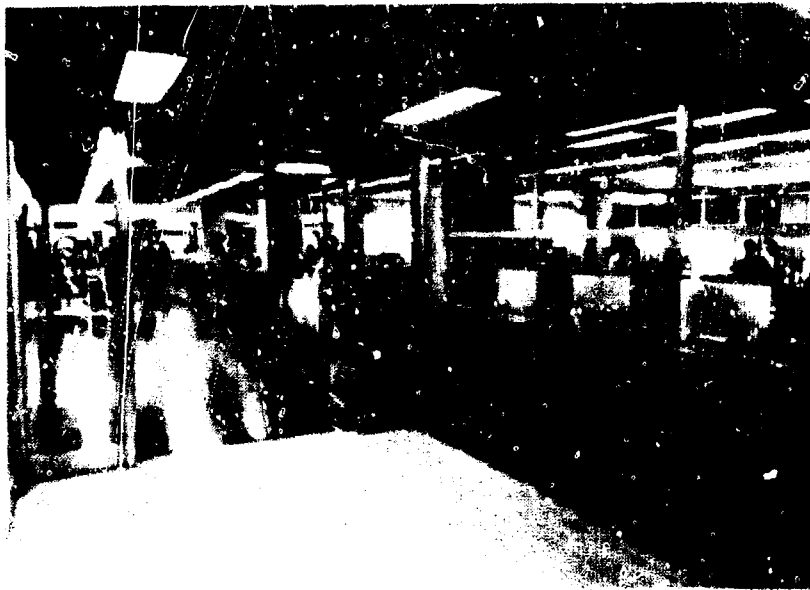
View 13 - The City-County Building -
An Interior View of an Office Section in
the Fourteen Story Tower Showing the Con-
struction of Some of the Interior Partitions

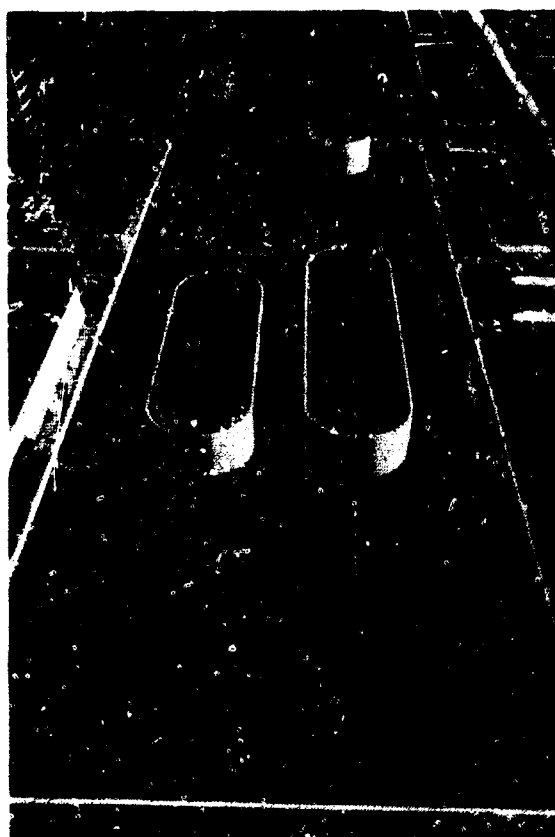
View 15 - The City-County Building -
A View of the Fourteen Story Tower Roof
Taken from the Roof of the Twenty Story
Tower

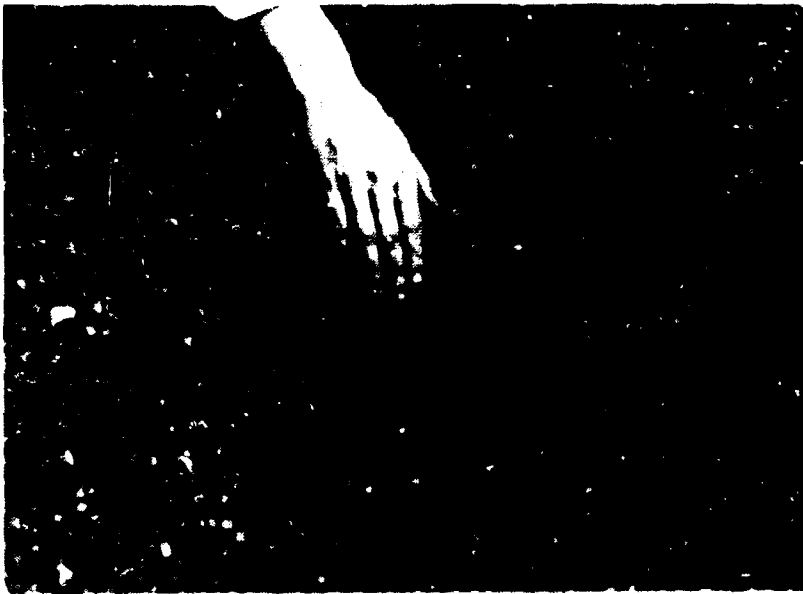
View 17 - The City-County Building -
A Close-up View Which Shows the Depth of
the Gravel on the Roof of the Twenty Story
Tower

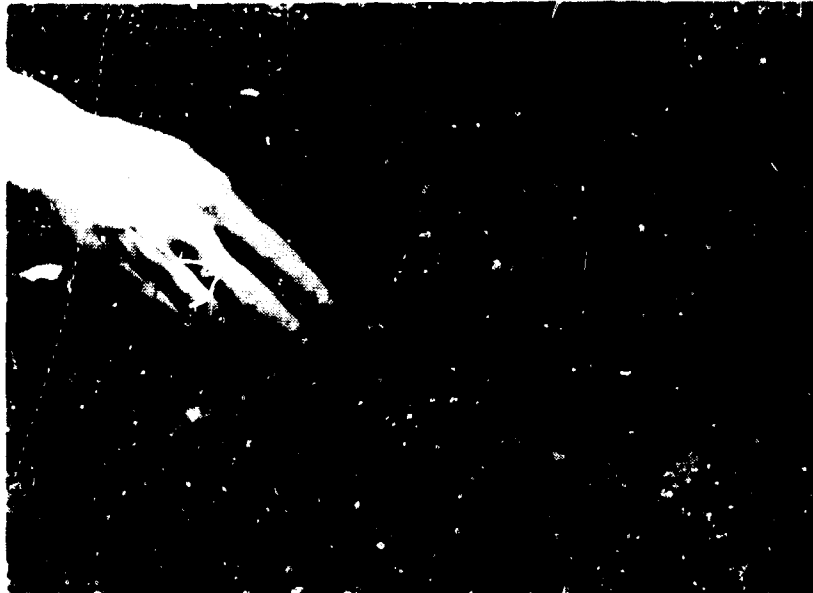
View 18 - The City-County Building -
A Close-up View of One of the Drains
on the Twenty Story Tower Roof

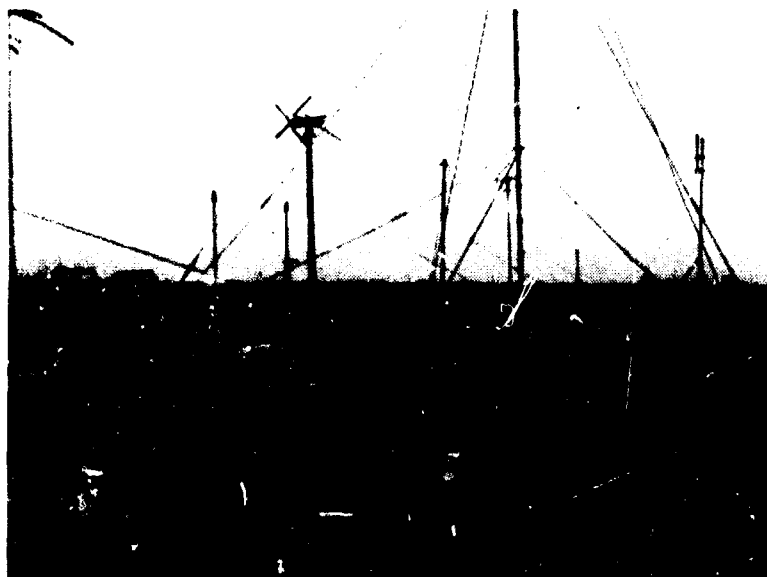
View 11 - Detroit City Airport -
A View of the Roof of the Terminal
Building Showing Several Antennae and
Other Obstructions to Decontamination

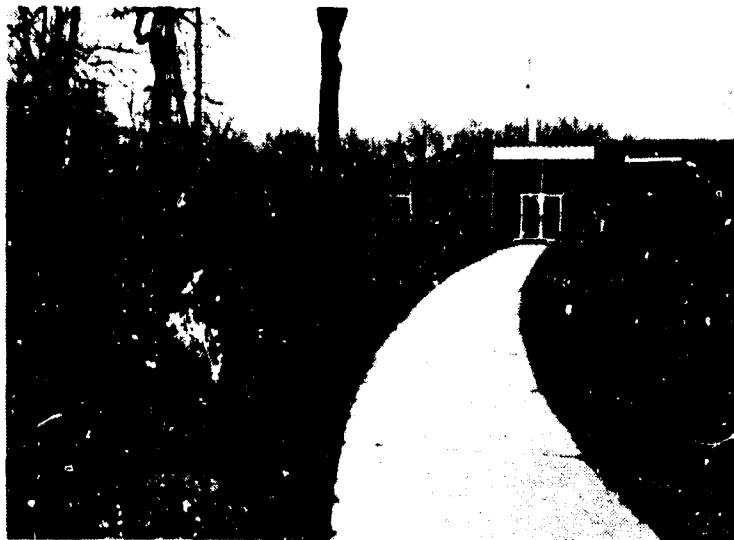
View 1 - Detroit OCD Building -
A View of the Front of the Building
Showing the Large Grass Lawn, a Sewage
Drain, and the Large Windows in Front
of the Building
